Contract #: 04-0120F4Cty: SF/ALA Rte: 80 PM: 13.2/13.9File #: 1.28**WELDING INSPECTION REPORT****Resident Engineer:** Casey, William**Address:** 333 Burma Road**City:** Oakland, CA 94607**Report No:** WIR-028958**Date Inspected:** 09-Jan-2013**Project Name:** SAS Superstructure**OSM Arrival Time:** 700**Prime Contractor:** American Bridge/Fluor Enterprises, a JV**OSM Departure Time:** 1730**Contractor:** American Bridge/Fluor Enterprises, a JV**Location:** Job Site**CWI Name:** Fred Michels and Barry Drake**CWI Present:** Yes No**Inspected CWI report:** Yes No N/A**Rod Oven in Use:** Yes No N/A**Electrode to specification:** Yes No N/A**Weld Procedures Followed:** Yes No N/A**Qualified Welders:** Yes No N/A**Verified Joint Fit-up:** Yes No N/A**Approved Drawings:** Yes No N/A**Approved WPS:** Yes No N/A**Delayed / Cancelled:** Yes No N/A**Bridge No:** 34-0006**Component:** SAS Tower and OBG**Summary of Items Observed:**

WELDING INSPECTION REPORT

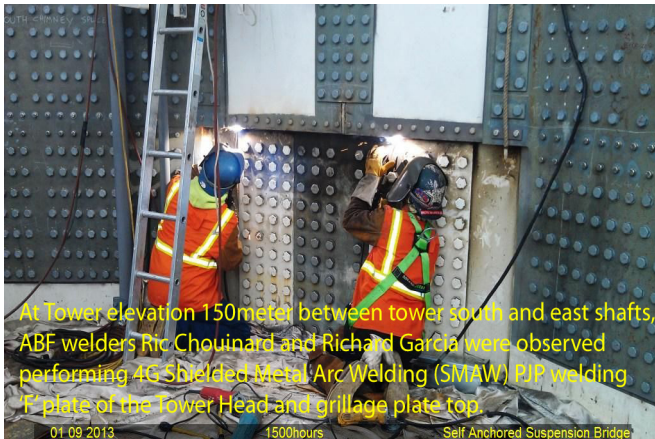
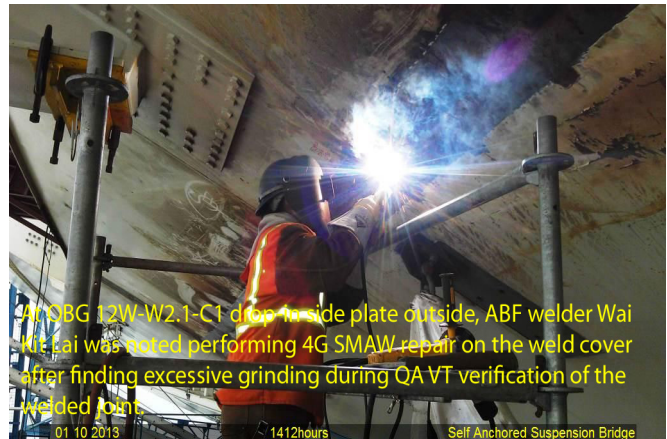
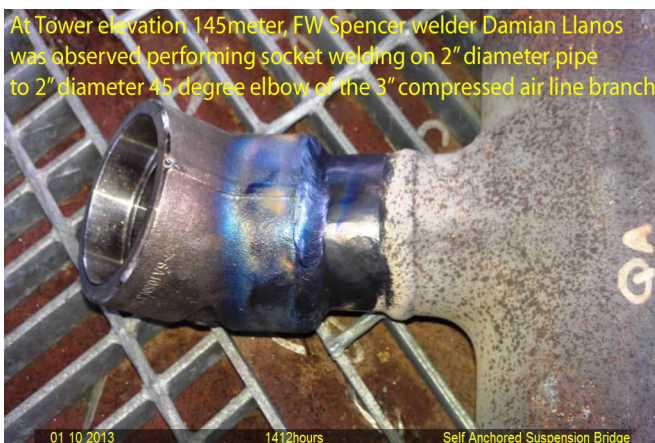
At Tower elevation 154meter, ABF welder Richard Garcia was observed continuing to perform all around 8mm fillet welding on four (4) 300mm long x 150mm wide x 12mm bracket plate for Tower Head to grillage ladder between south shaft and east shaft chimney. The welder was noted using self-shielded Flux Cored Arc Welding (FCAW-S) with 1.6mm E71T-8 wire electrode implementing ABF-WPS-D1.5-F2200-3. The bracket plates being welded are the holding bracket for the tower head to grillage ladder. Prior welding, the plates were preheated using propylene gas torch. During the shift, ABF QC Fred Michels was noted on site monitoring the welder Richard Garcia. During the shift, 8mm all around fillet welding of the four bracket plates for the ladder was completed.

After the completion of the four holding brackets for the tower head to grillage ladder, ABF welder Ric Chouinard was noted perform carbon air arc gouging to put a bevel on the 'F' plate in preparation for the PJP welding between the same 'F' plate to top of the grillage plate per reference cross section E-E of the Tower Head Details No. 7. The welder ground smooth the surface of the gouged area and then performed 4G Shielded Metal Arc Welding (SMAW) welding root pass on the PJP weld joint. Another ABF welder Richard Garcia was also noted performing root pass welding on the same joint. After the completion of the root pass, ABF QC Fred Michels performed Magnetic Particle Testing (MT) on the completely welded root pass. ABF QC has found no significant indication during the MT and so the two welders Ric Chouinard and Richard Garcia resumed welding fill pass until the end of the shift.

At tower elevation 145meter, this QA randomly observed FW Spencer qualified welder Damian Llanos perform socket welding on 2" diameter pipe to 2" diameter 45 degree elbow using Shielded Metal Arc Welding (SMAW). The system line being welded is a compressed air field branch joint near the tower head. The welder was noted preheating and removing the moisture of the joint using a portable propane gas torch prior welding. During welding, ABF QC Barry Drake was noted monitoring the parameters of the welder. At the end of the shift, two (2) 2" diameter field branch joints were completed.
